# historic structure report

## restore historic commissary building to 1897

# FORT SMITH

HISTORIC STRUCTURE REPORT  
RESTORE HISTORIC COMMISSARY BUILDING TO 1897

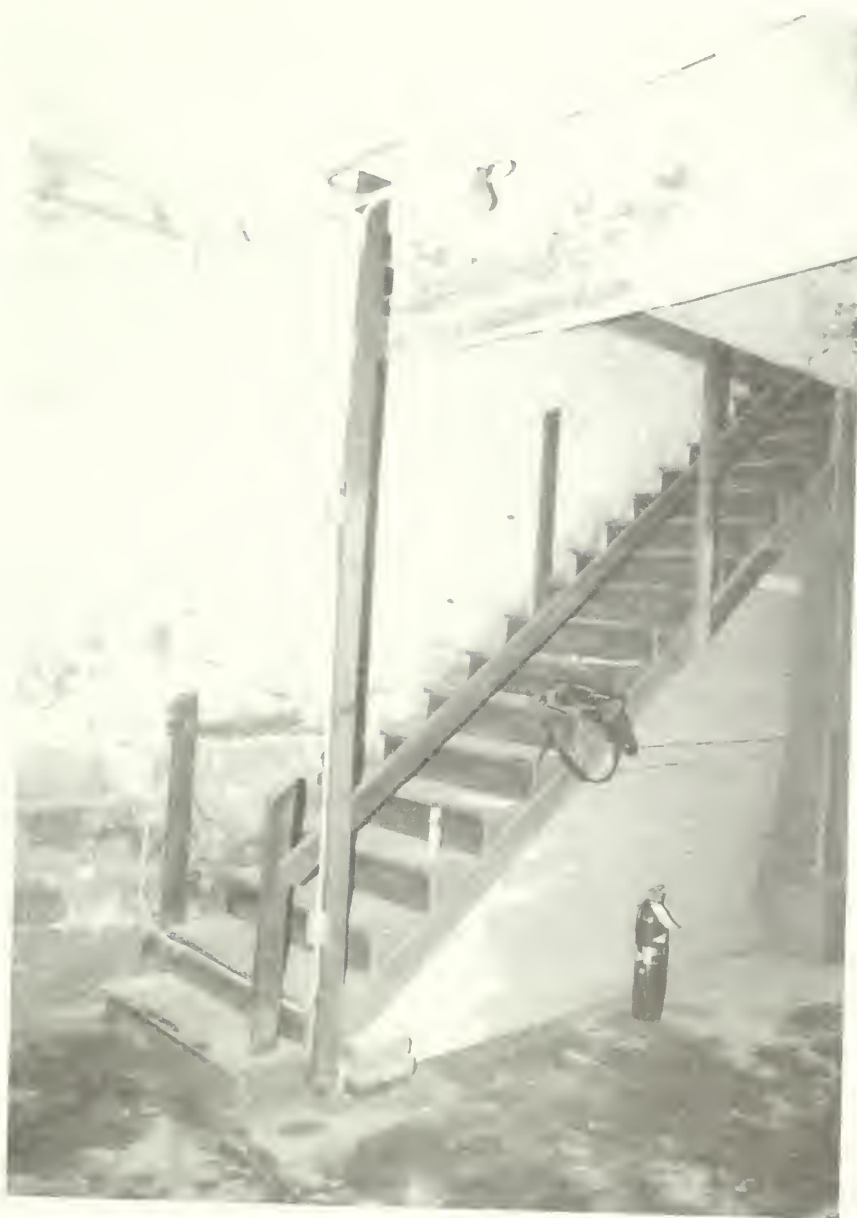
Figure 7. Stair 2 (5/18/82): Built about 1936 to serve the museum function, this stairway enlarged the historic stairwell opening but utilized salvaged material from a former stair in the new stairwell header (see figure 10). This stair was removed along with the washroom and concrete floor below it in 1984.

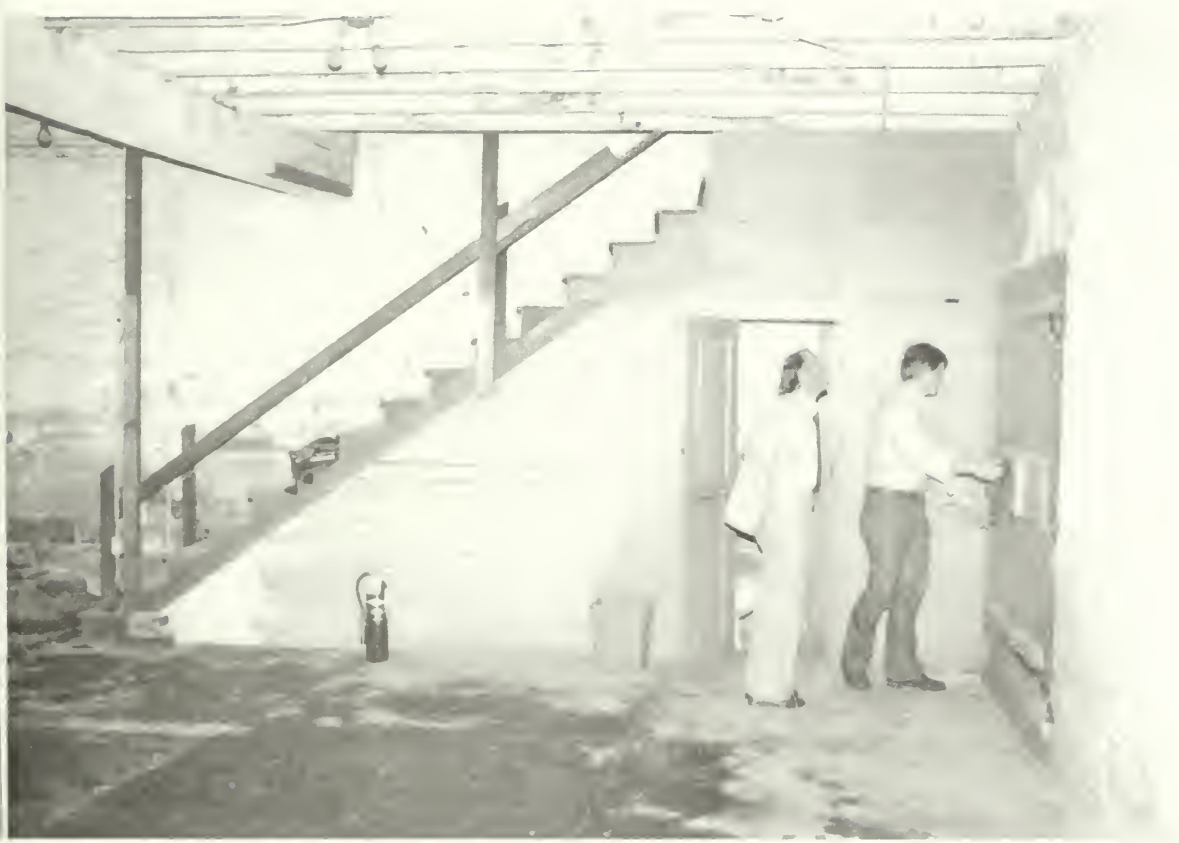
Figure 8. Stair 2 (5/18/82): This stair was 18' long, including the washroom, and 39" wide at the foot. Treads were 3/4"x11-1/2" with 1" nose, and eighteen 7-3/8" risers totalled 11'-3/4", with a total run of 14'-10 1/2". Its structure of 2x4 stock was infested with termites.

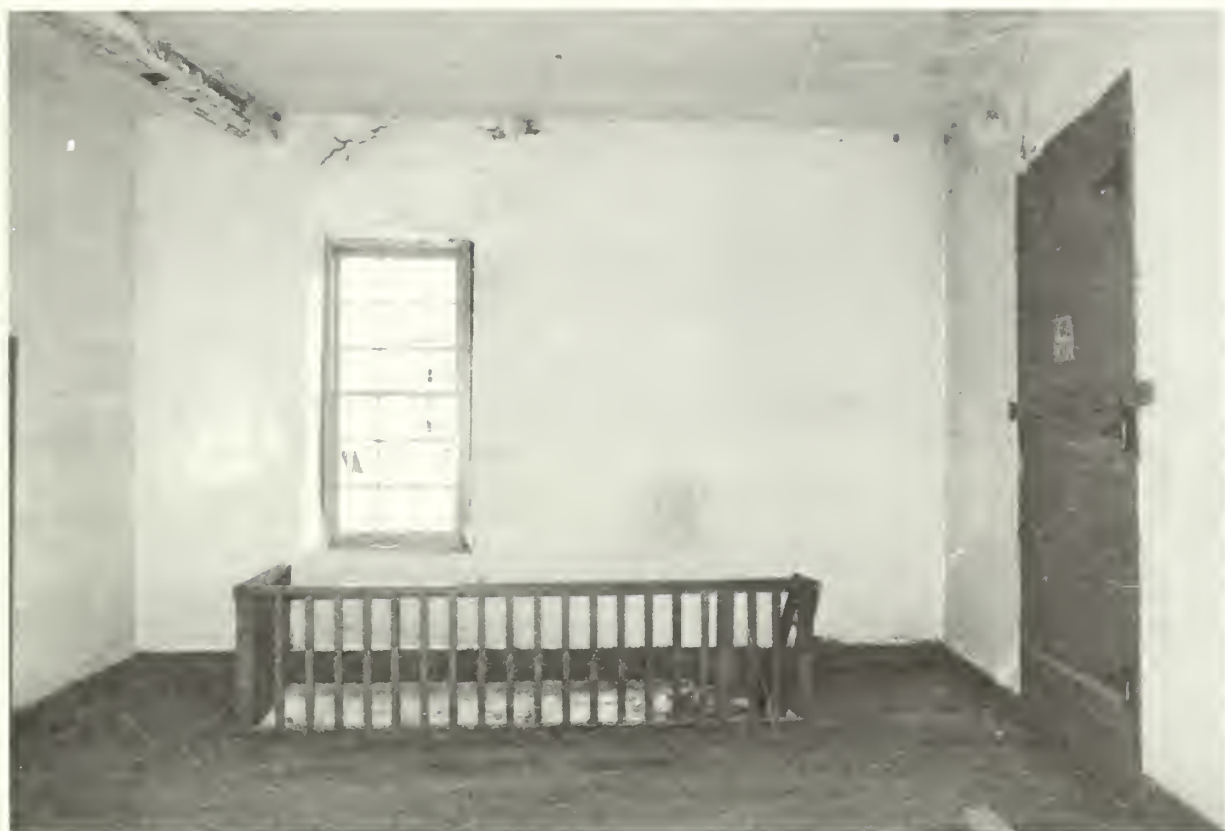
Figure 9. Stairwell Handrail (1/3/85): Undisturbed by the 1983-84 work, the railing shown here is historic--possibly installed in 1866 or during the Judge Parker era (1886). It was extended 19" in length--in photo at right--by two balusters and a new 2x4 end post similar to the original. This extension was done about 1936 when the stairwell was enlarged and new stair installed. The rail appears to have been built contemporaneously with the installation of the 1"x8" baseboard on the east wall--referred to by Parker in 1886, but probably installed earlier (perhaps 1866).

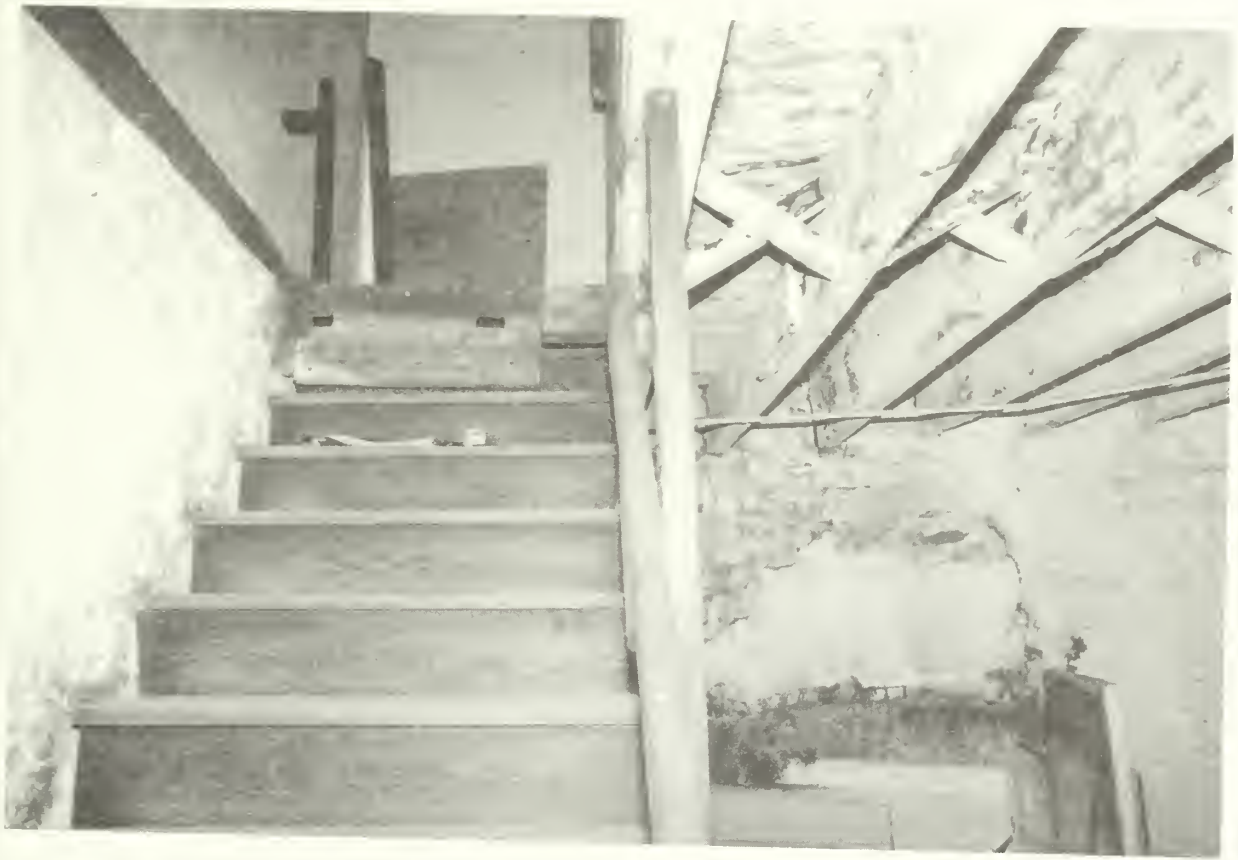
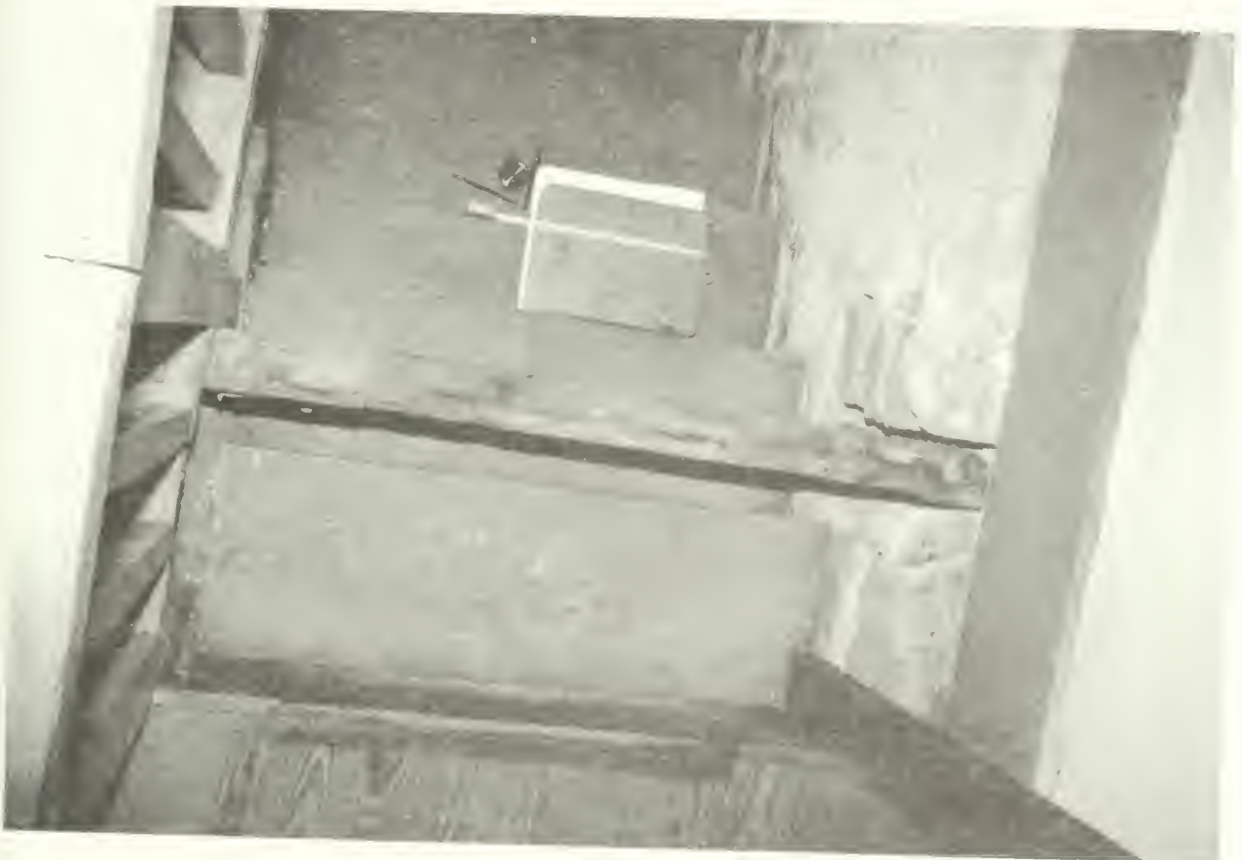
Figure 10. Historic Stairwell Header (5/18/82): Most of the original stairwell header--an architectural relic--is in the possession of the park and shown here in its historic position. The header was notched to rest in the masonry pocket at one side, and a tenon on the other fit into a socket in the first continuous ceiling joist. The two holes in the header received tenons of ceiling joists which ran back to the wall. In the plan view (lower photo) it is clear where the handrailing ended historically and where the floor has been removed to lengthen the stairwell.

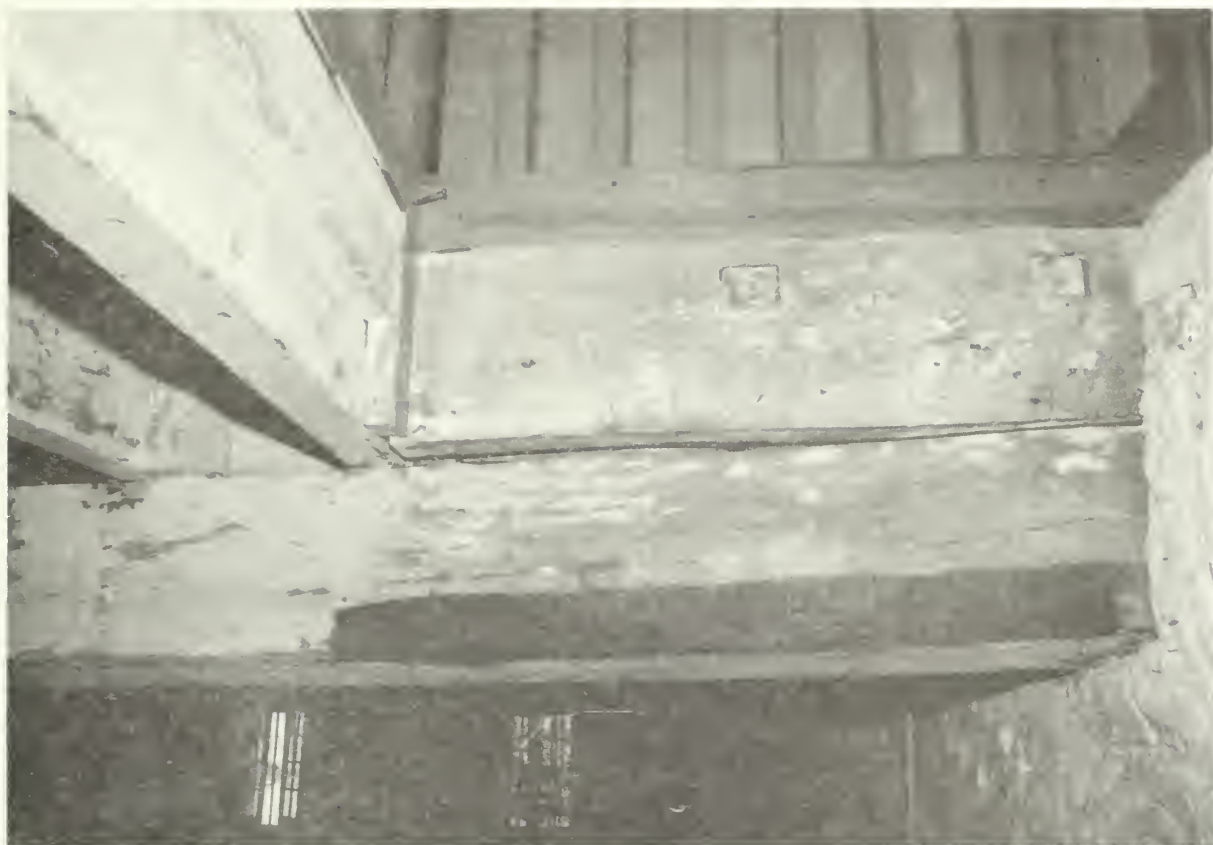
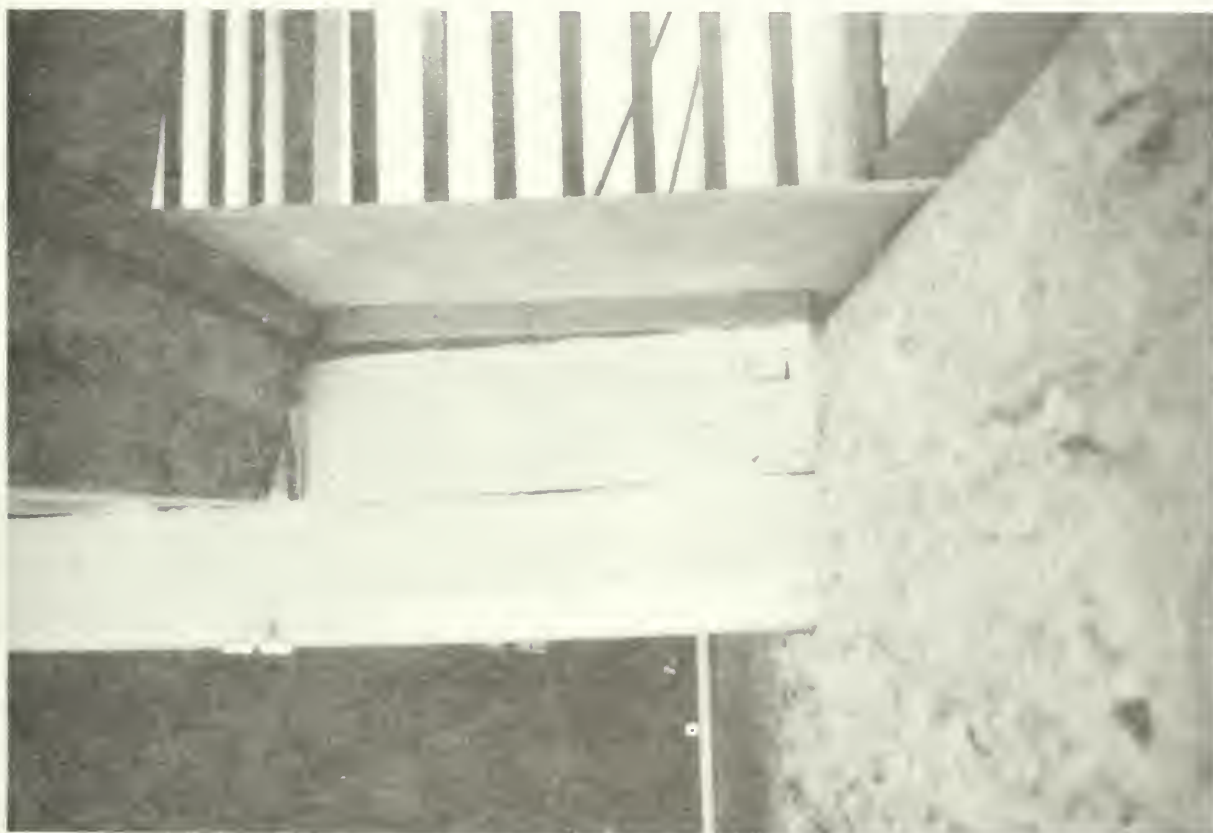
Figure 11: North Header of Stairwell (5/18/82 and 1/3/85). These views of the north end of the stairwell were taken before (above) and after (below) restoration of whitewash. In the upper view it is clear that the transverse beam was notched--probably about 1936--to facilitate stair 2; the notch had never been whitewashed over. The implication is that stair 2 had a longer and/or less steep run than the original stair, requiring additional head clearance. Note, also, the ledger board attached to the joist at the left, which may have been part of a historic stairwell cover when it was not in use.

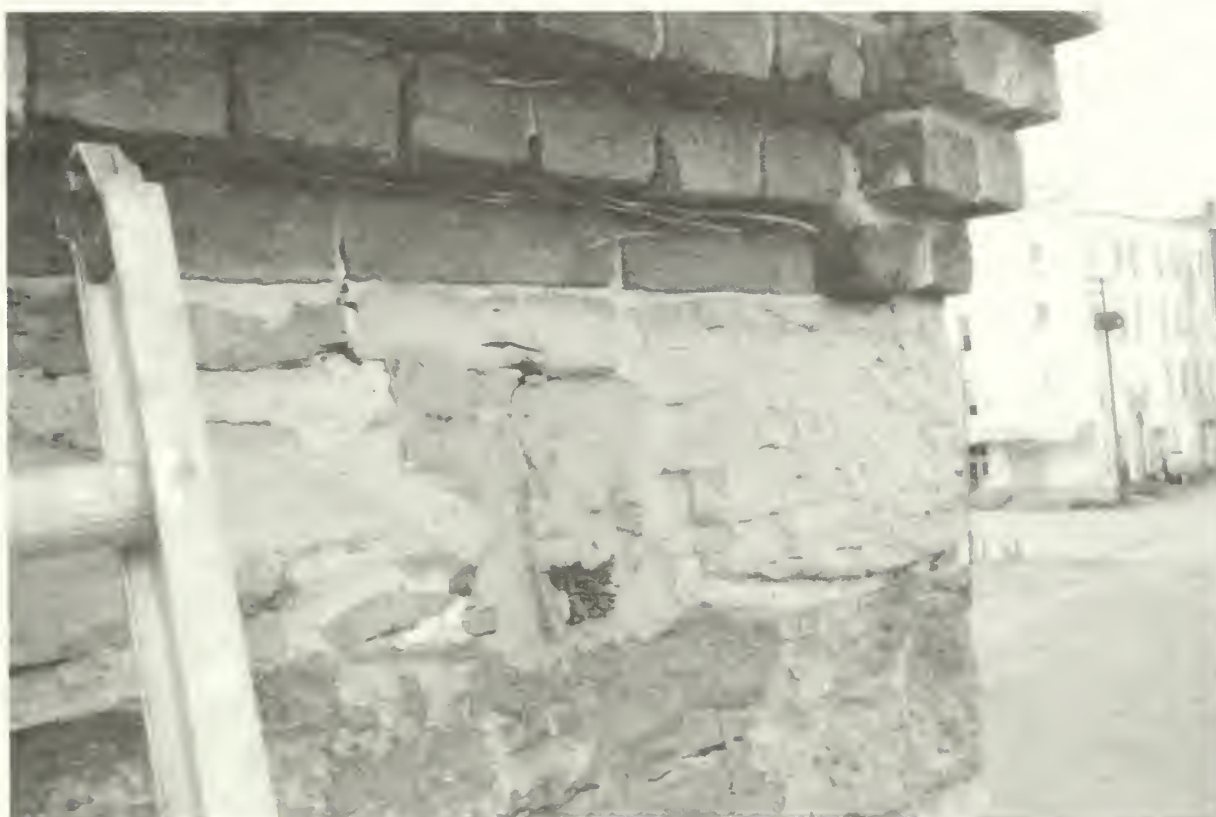
Figure 18. Beam Pocket (6/25/83): Typical upper beam pocket on south facade before restoration. Fragment of wood remains in place. Pocket was filled about 1913 with cement mortar, generously applied. The fragment is a remnant of the roof structure for porches 3 and 5, which hung here from 1866 to approximately 1896.

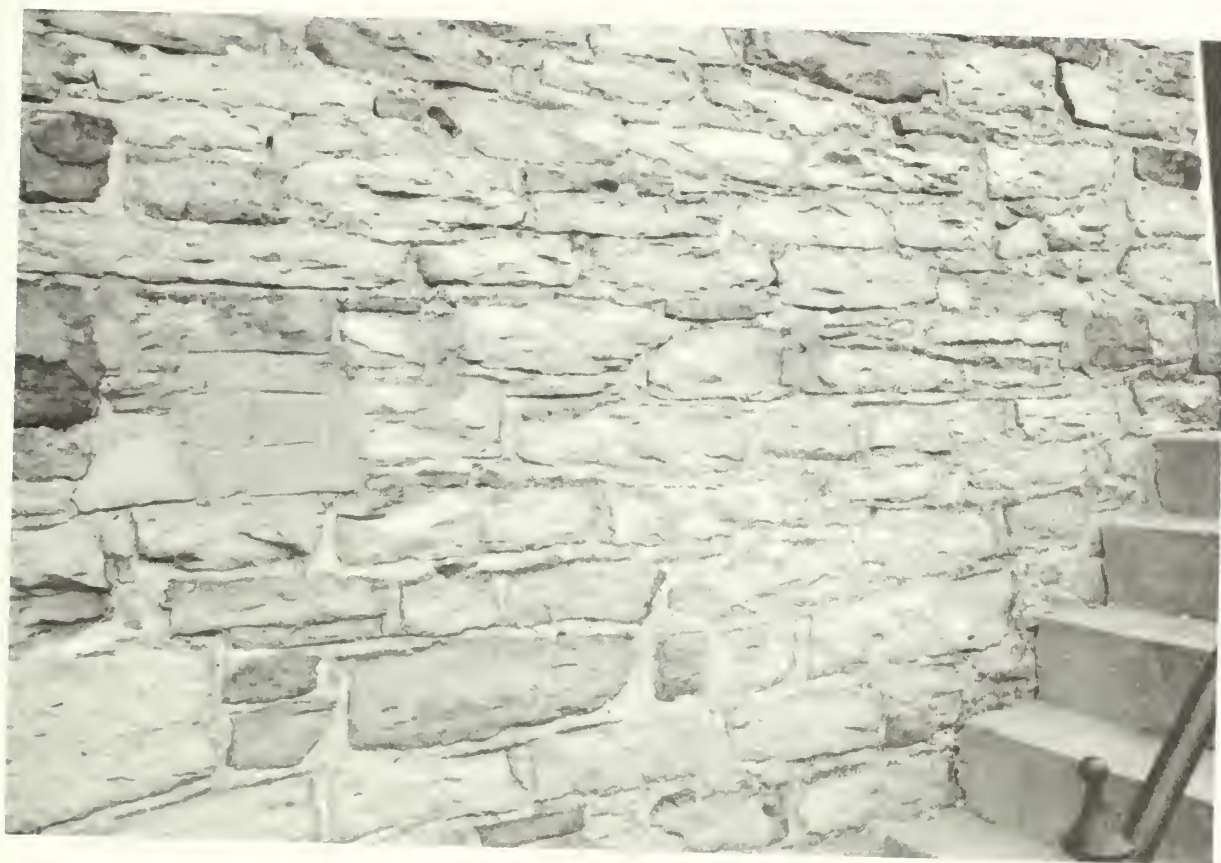
Figure 19. Beam Pocket (6/25/83): The beam pocket at left, filled in about 1913, was scribed to blend with the masonry pattern of the wall. Four smaller cement fills are visible at the level of the door sill stone (at far right). These fills cover up wooden nailers, probably used to attach a porch baseboard or floor header board for porch 5. All of these features were rehabilitated for interpretation.

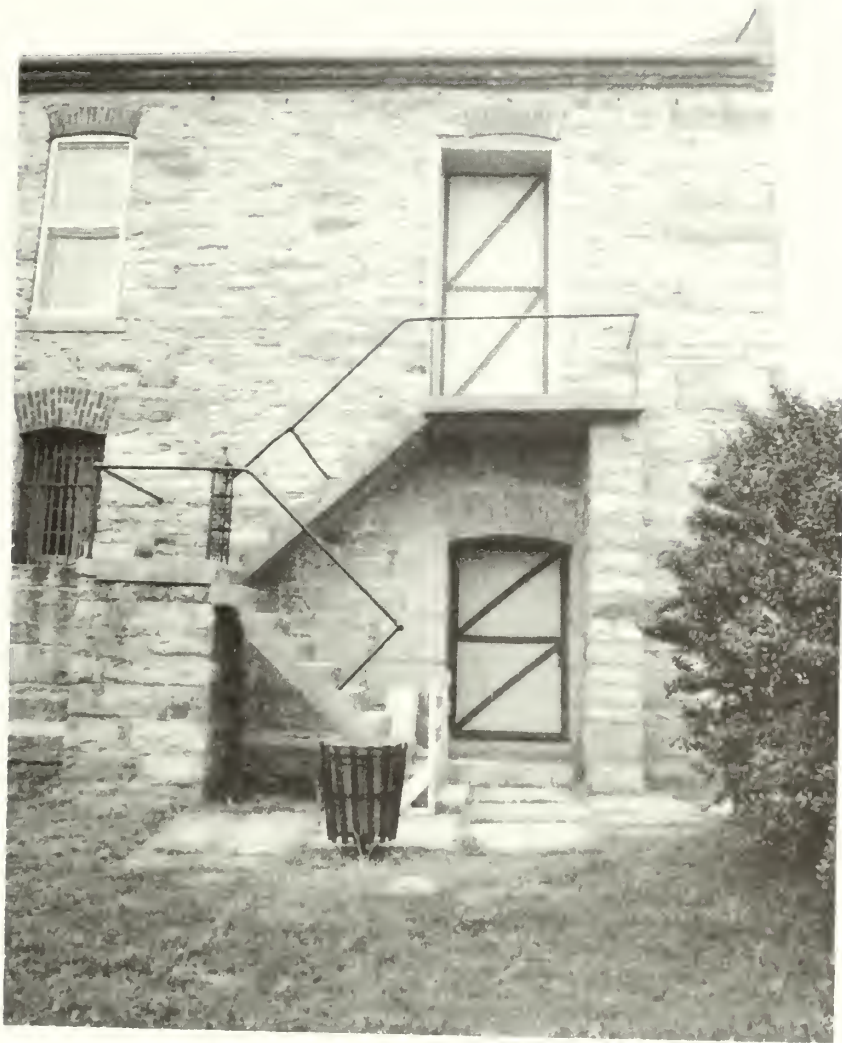
Figure 24. Porch 7 (5/18/82): This porch was built about 1913 to serve the museum functions. It was removed--being an unjustifiable modern intrusion--in 1984.

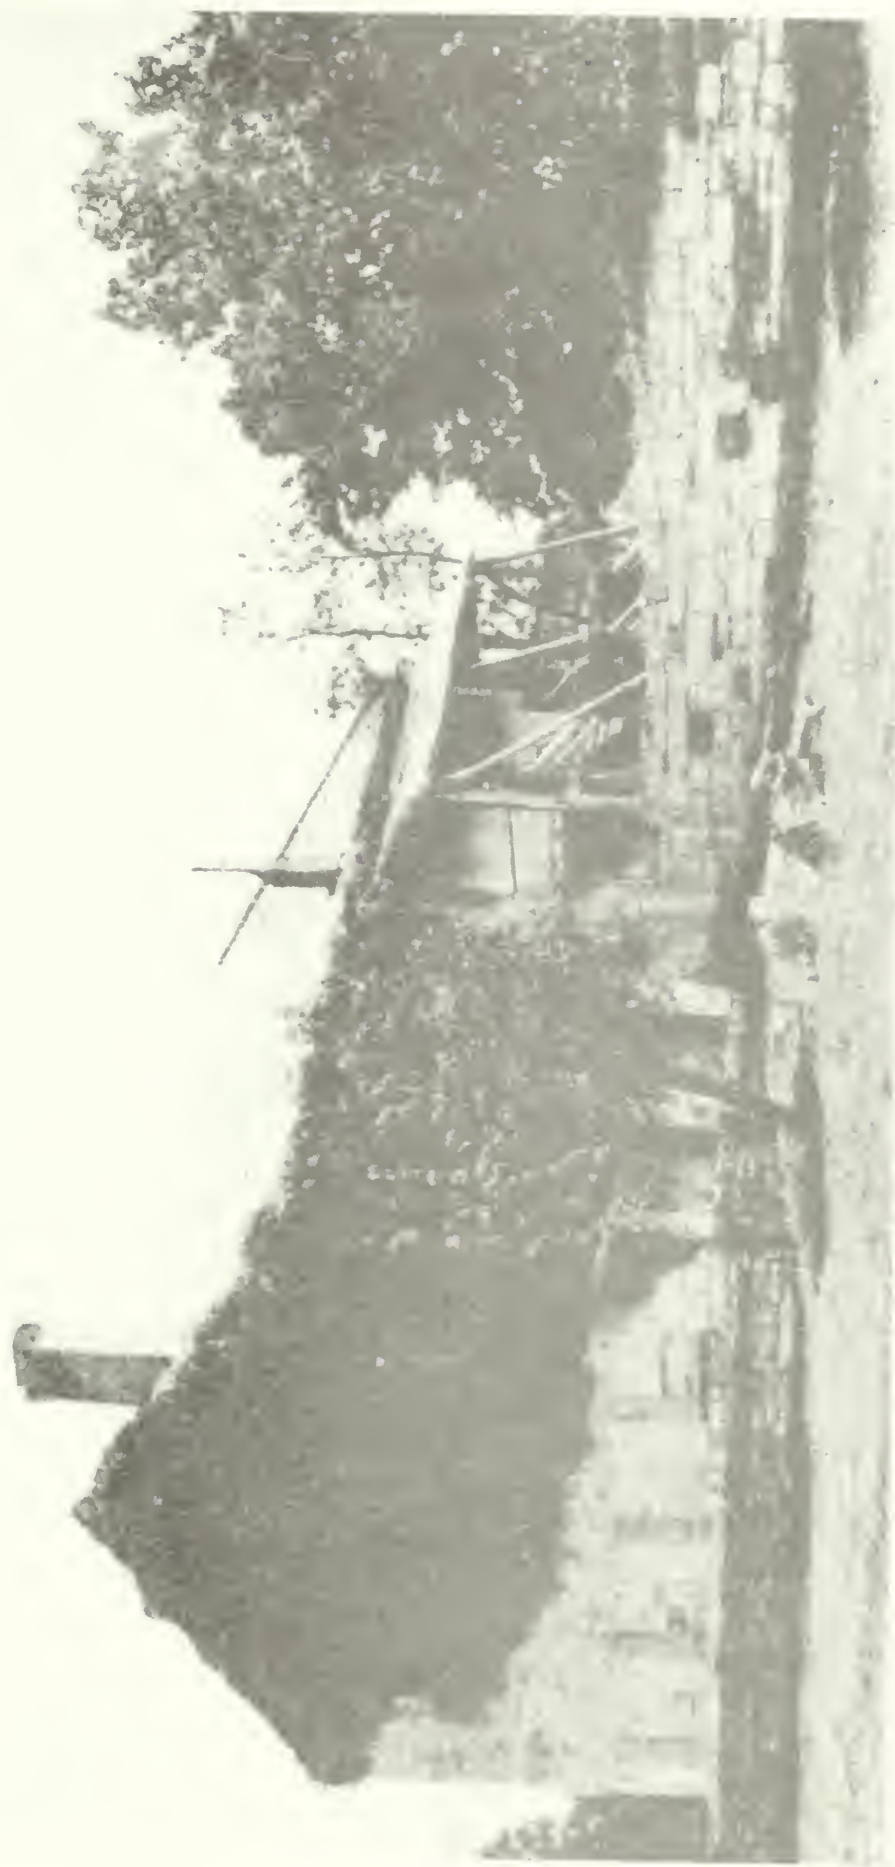
Figure 31. FOSM-IV-178 (ca. 1894): This photograph was taken about the same time as figures 32 and 33. Taken from the west, it shows the presence and condition of the chimneys, the west curtain wall of the fort, support blocks for porch 3, the dilapidated porch 5, and the extent of vine growth which was allowed to cover the structure during its occupation as quarters by the Federal Court period personnel.

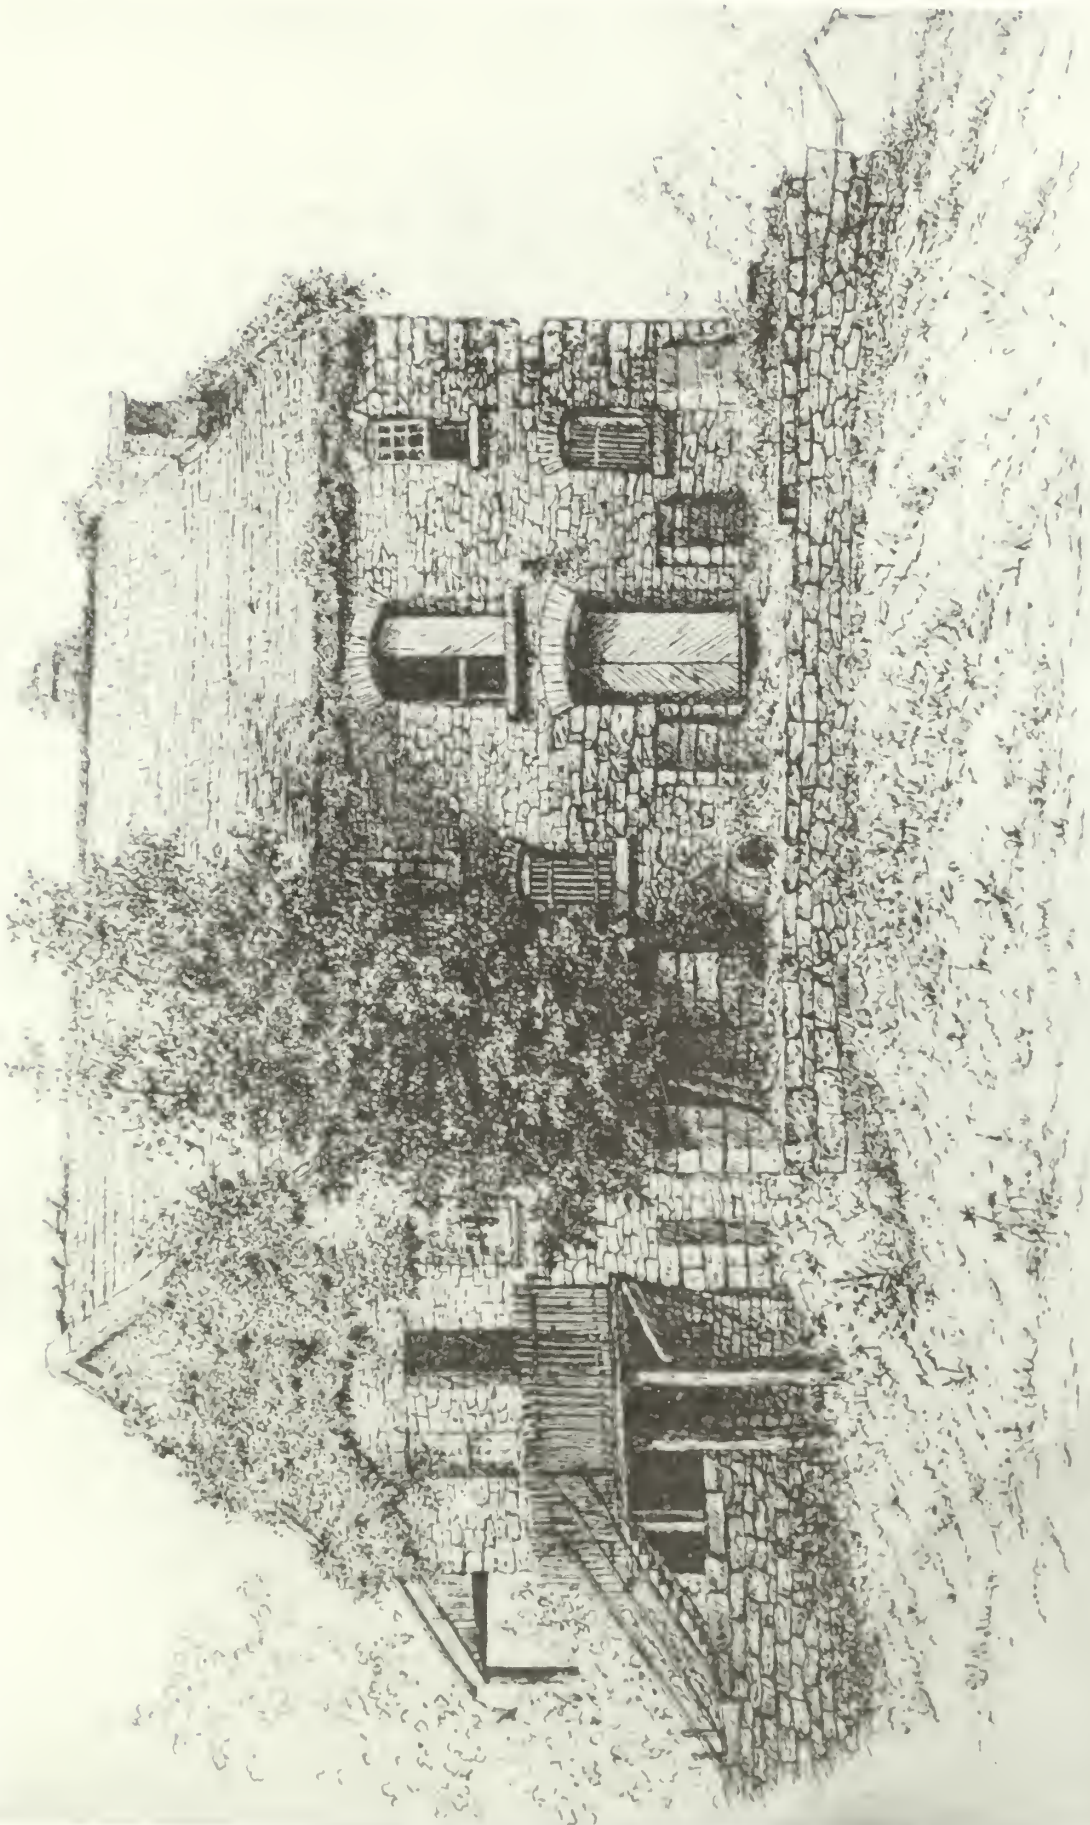
Figure 32. FOSM-II-99 (1894): This sketch, viewing from the east, was made by R.H. Mohler (signed and dated at lower left). It shows the last historic east porch 2 and south porch 5; suggests dilapidated wood shingles, excessive vine coverage, and provides good evidence for chimney, door, and window design and the historic shape of the landscape near the end of the Federal Court period.

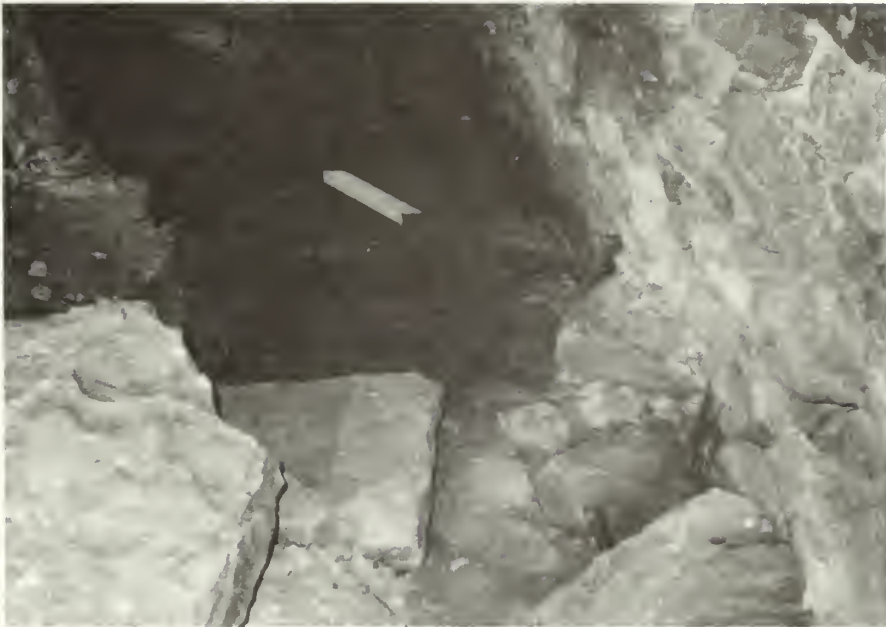
Figure 53. Gorge of bastion 1, after lifting flagstones from the ground floor of the commissary to insert utility lines.

If the flagstones inside the commissary are ever lifted, an effort should be made to determine if the parados foundation still exists. Depth and artifactual content of the flagstone bedding should be ascertained.

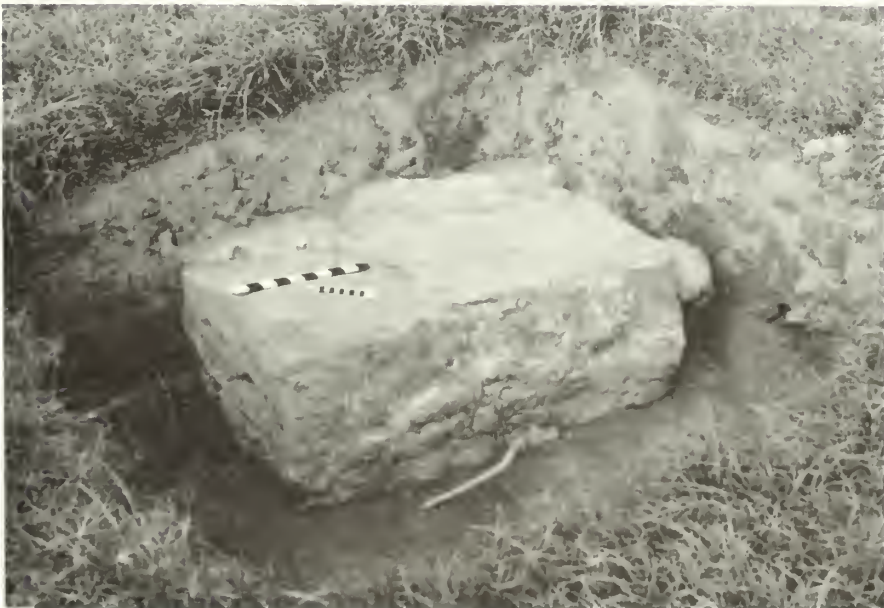
survive (tests 11, 15 and 16). The stone piers consist of several courses of sandstone mortared in place. Both are square in shape, 2.5 feet to a side (fig. 54). Because mortar adheres to their surfaces, it may be assumed that one or more courses of stone were removed in the past, perhaps during the 1911 grading. The piers align perfectly with the beam pockets cut into the southern facade of the building. A third stone pier, visible in a period photograph, was removed sometime in the past.<sup>21</sup> It would have been located in test 14. A fourth support post should have rested on the curtain wall, but may in fact have been offset. A 1.0-foot-square post mold is situated in line with the two surviving piers, immediately adjacent to the curtain wall (test 11). Although evidence of the two easternmost support posts was not discovered, the beam pockets are still in place. A full-length porch, 8.0 x 48.0 feet, is indicated. Both surviving piers are enveloped but not covered by the 1898-1899 fill, suggesting that the porch may have been full-length at the time the fill was deposited.

Figure 54. Stone Pier: This pier was used for a support beam of the south porch in test 15.

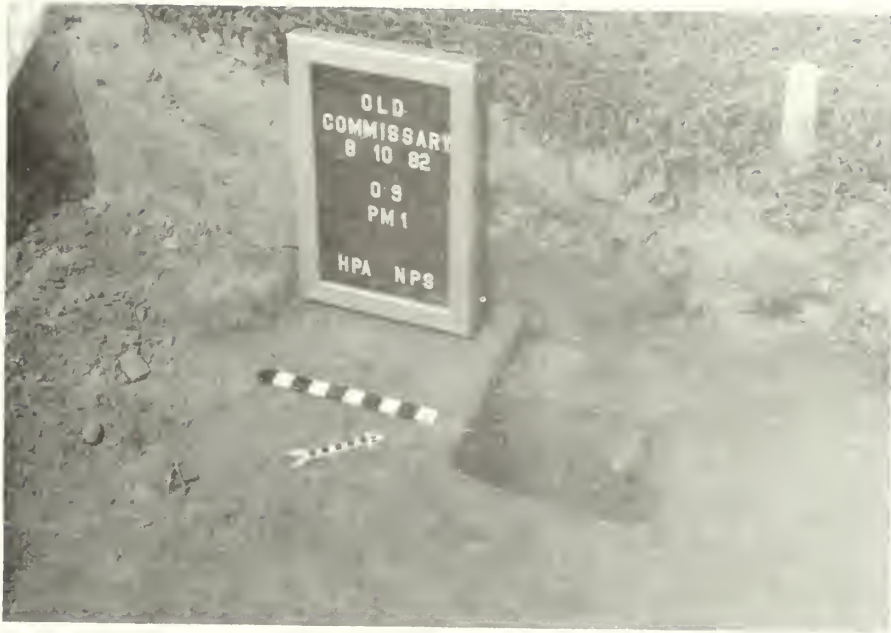
Two post molds, probably related to the 1866-67 porch on the east side of the commissary, were identified in test 4 (fig. 47). The first post mold is 0.4 foot or 5 inches square (fig. 55). It extends 2.0 feet below ground surface into the sterile B22t horizon of Muskogee silt loam. The second post mold is only 4.5 feet to the north. This feature is much disturbed, however, as if a post had been "levered out" of the ground.<sup>22</sup> The second post mold is directly under a beam pocket cut into the east facade of the commissary building and, therefore, is probably the remains of a support post. Both post molds are 8.0 feet from the wall of the building, suggesting a porch width identical to that for the north and south porches constructed the same year.

Figure 55. Square Post Mold: One of the post molds marking a former support beam for the 1866-67 porch on the east side of the commissary.

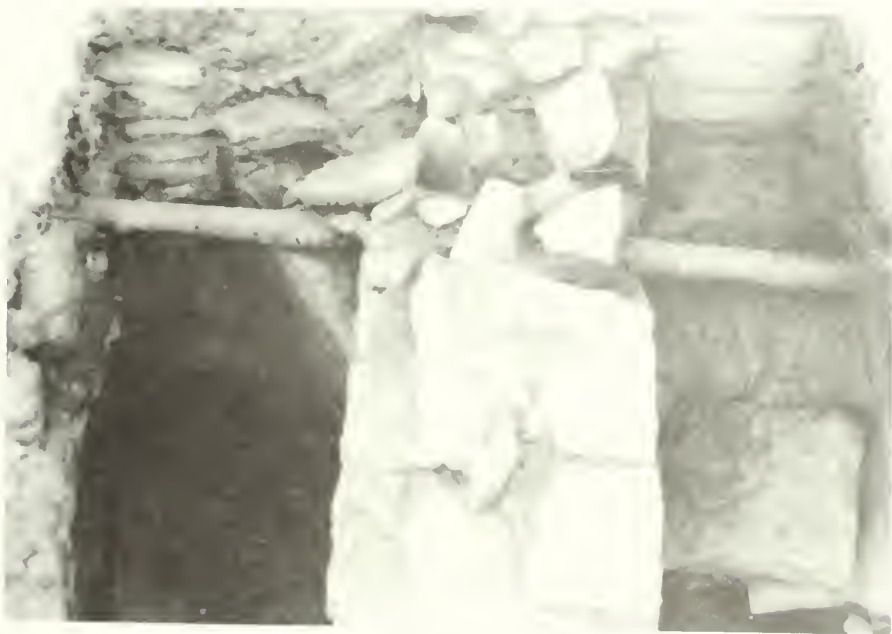
A flagstone walk has been identified on the east side of the commissary (fig. 56). The feature abuts the east curtain wall and parallels the commissary foundation for an unknown distance. The walk is exactly 5.8 feet wide and is approximately 1.5 feet below the surface, placing this feature near the military ground surface. Mortar used in walk construction could shed additional light on the affiliation of this feature, but, unfortunately, this information was not recorded. It is entirely possible that the walk is related to one of the two porches that existed on the east side of the building. Conceivably, the flagstones may have led to the steps on the east end of the north porch. Additional investigation is warranted, however, before making a conclusion.

Figure 56. Flagstone Walk: This feature abuts the curtain wall on the east or right flank of the commissary. Presumably, the walk is associated with one of the historic porches.

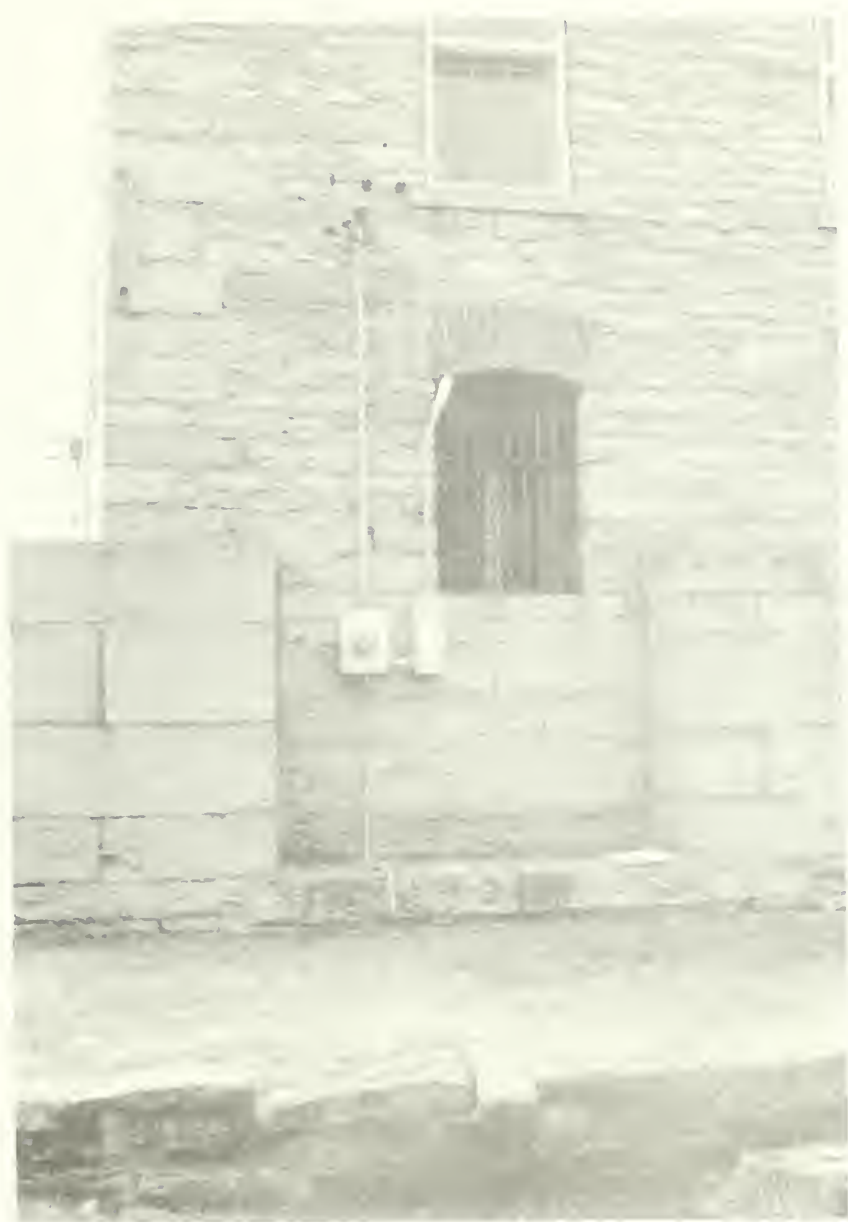
Figure 62. First Floor (6/26/83): Detail shows octopus arrangement of electrical conduit entering the commissary at its east corner. The 200 amp panel box was relocated in 1984 to an enclosed panel cabinet, and all lines and fixtures shown here were removed.

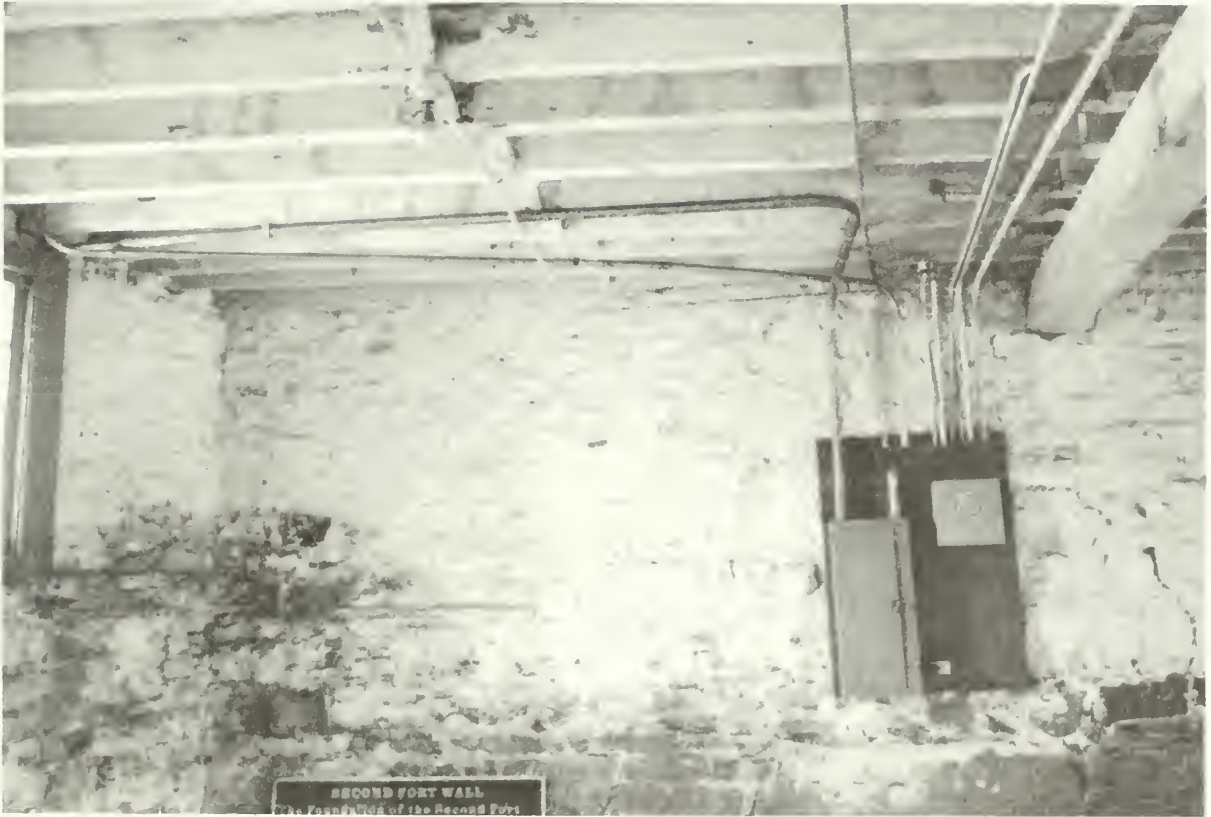
Figure 63. First Floor (6/26/83): General view of first-floor condition before restoration. Note light fixtures, gas stove heaters, and concrete slab floor that were removed, and deteriorated support posts and whitewash that were restored.

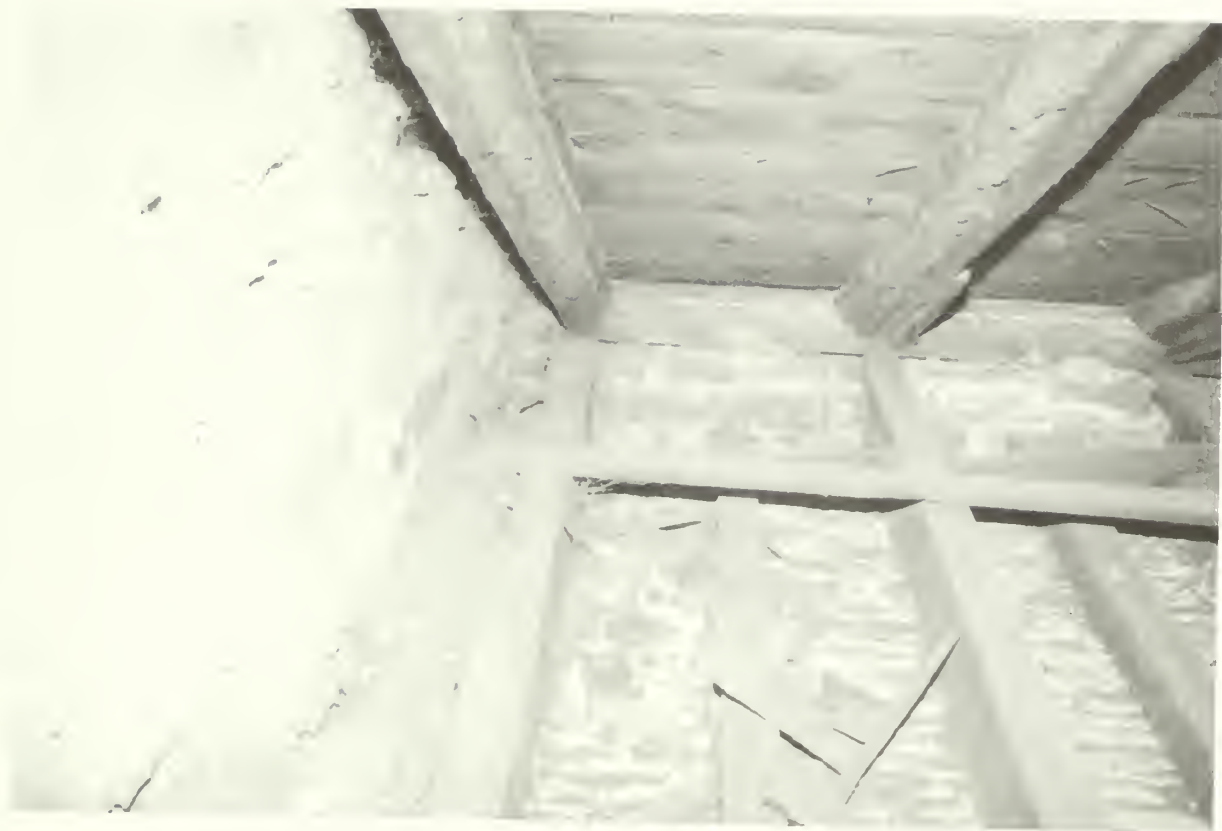
Figure 65. Attic (6/25/83): This photograph shows historic construction details now covered up by new work. Brick nogging filled the space between rough cut 3/8" attic floor joists and provided a backing for the brick cornice and a base for the rafter plate. The 4" by 4" rafters were roughly hewn from poles and notched to sit on the 2" by 6" plate where they were spiked. Rough cut 3" by 3" intermediate joists were set in place in 1866 to help carry the second-floor ceiling lathe and plaster. The gable end walls, of stone, were built 6 inches thinner, as they rise above the attic-floor level. Note also, fragments of slate shingles and the obviously newer roof sheathing that was probably installed in 1938.

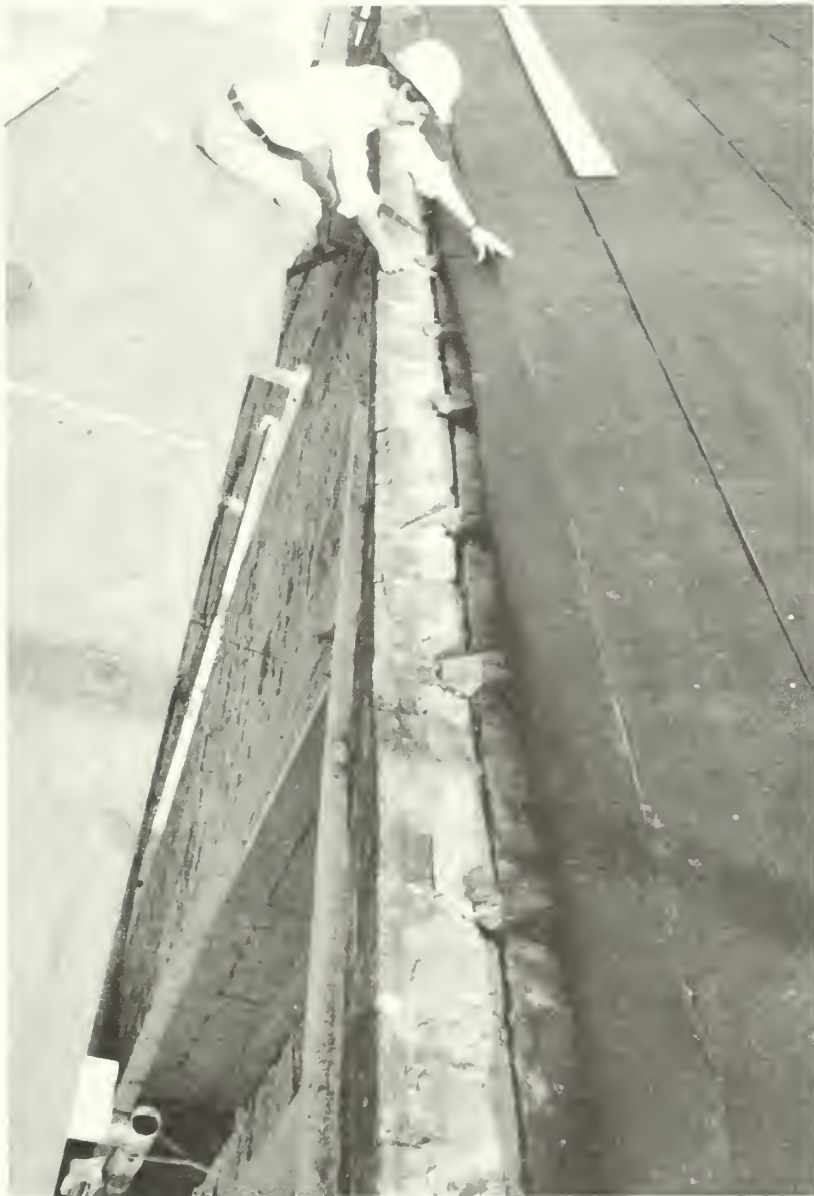
Figure 69. South Brick Cornice (10/8/83): The brick dismantled effortlessly because the lime mortar had become quite useless. Rafter tails too, were exposed to inspection, and although somewhat weathered, their condition was generally very good for their 140-year age. In some cases, sister rafters were nailed to the existing to reinforce them as had been done traditionally - note left rafter in lower photo.
